# Manhole Inspection Summary

Manhole # S49CC\_011MH

Insp Date: **2/18/08 11:43 AM**

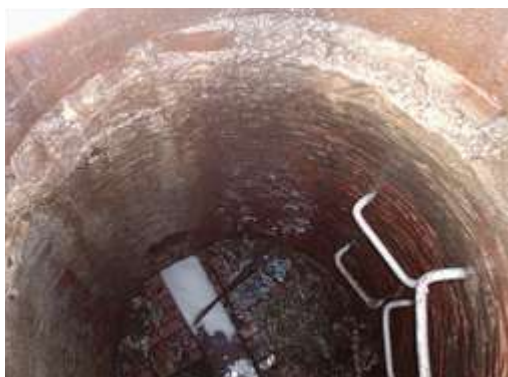
Defect 2

☒ **Leaks**

Frame Leaks

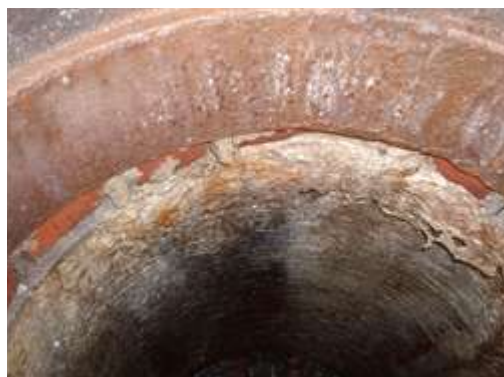
Defect 1

Infiltration: ☐ None ☐ Joint ☐ Cracks ☐ Mortar ☐ Roots ☒ **Wall**

Adjustment Frame

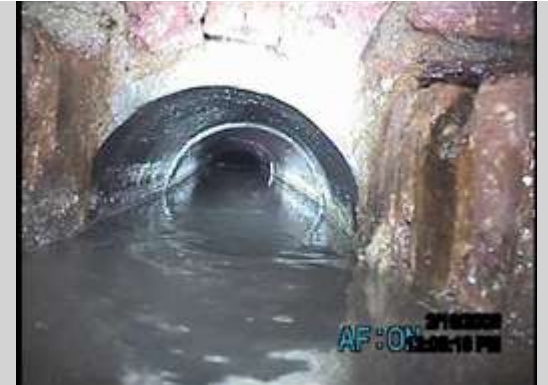
12 O'Clock Outflow

8 in. Circular Gravity Sewer  
Pipe Out @ 12 O'Clock

Pipe Height: **8.4** (in.) Rod and Bar (Angled)  
Pipe Material: **Clay** ☐ Pipe Lined  
Invert Depth: **10.20** (ft.) Flow Characteristics: **Fast**  
Deposits: ☐ None ☐ Mud ☐ Sludge ☒ **Debris** ☐ Grease  
Silt Depth: **4** (in.) Deposits Extent: **Heavy**  
Infiltration: **None** Pipe Seal Cond: **Sound**

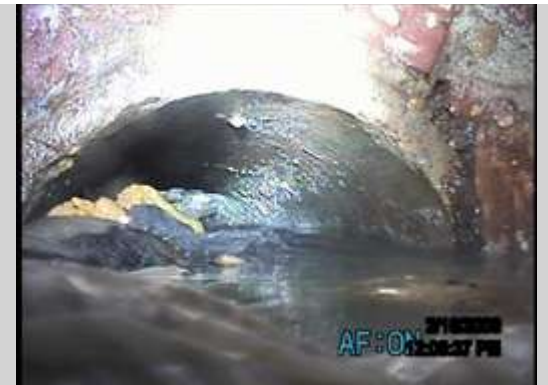
3 O'Clock Inflow

8 in. Circular Gravity Sewer  
Pipe In @ 3 O'Clock

Pipe Height: **8.4** (in.) Rod and Bar (Angled)  
Pipe Material: **Clay** ☐ Pipe Lined  
Invert Depth: **10.00** (ft.) Flow Characteristics: **Fast**  
Deposits: ☐ None ☐ Mud ☒ **Sludge** ☒ **Debris** ☐ Grease  
Silt Depth: **4** (in.) Deposits Extent: **Heavy**  
Infiltration: **None** Pipe Seal Cond: **Sound**

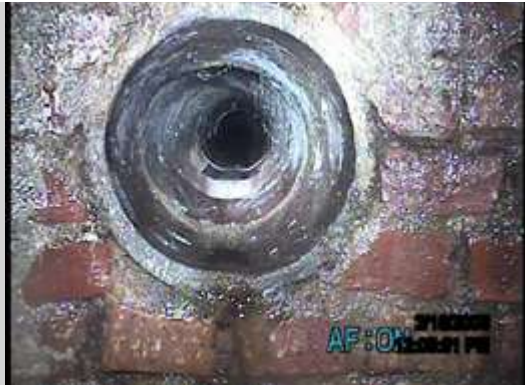
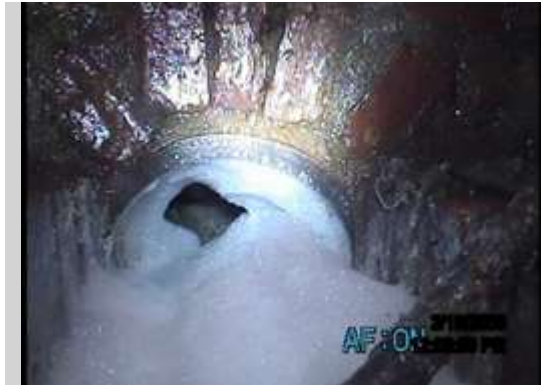
6 O'Clock Inflow

Pipe In @ 6 O'Clock

Drop In @ 6 O'Clock

Drop: <b>Outside</b>	Rod and Bar
Angled: <b>Yes</b>	Reading: <b>8.91</b> (ft.)
	Inv Depth: <b>9.91</b> (ft.)
Drop Condition: <b>Open</b>
